INDUSTRY RESEARCH REPORT

Indoor Coil Corrosion

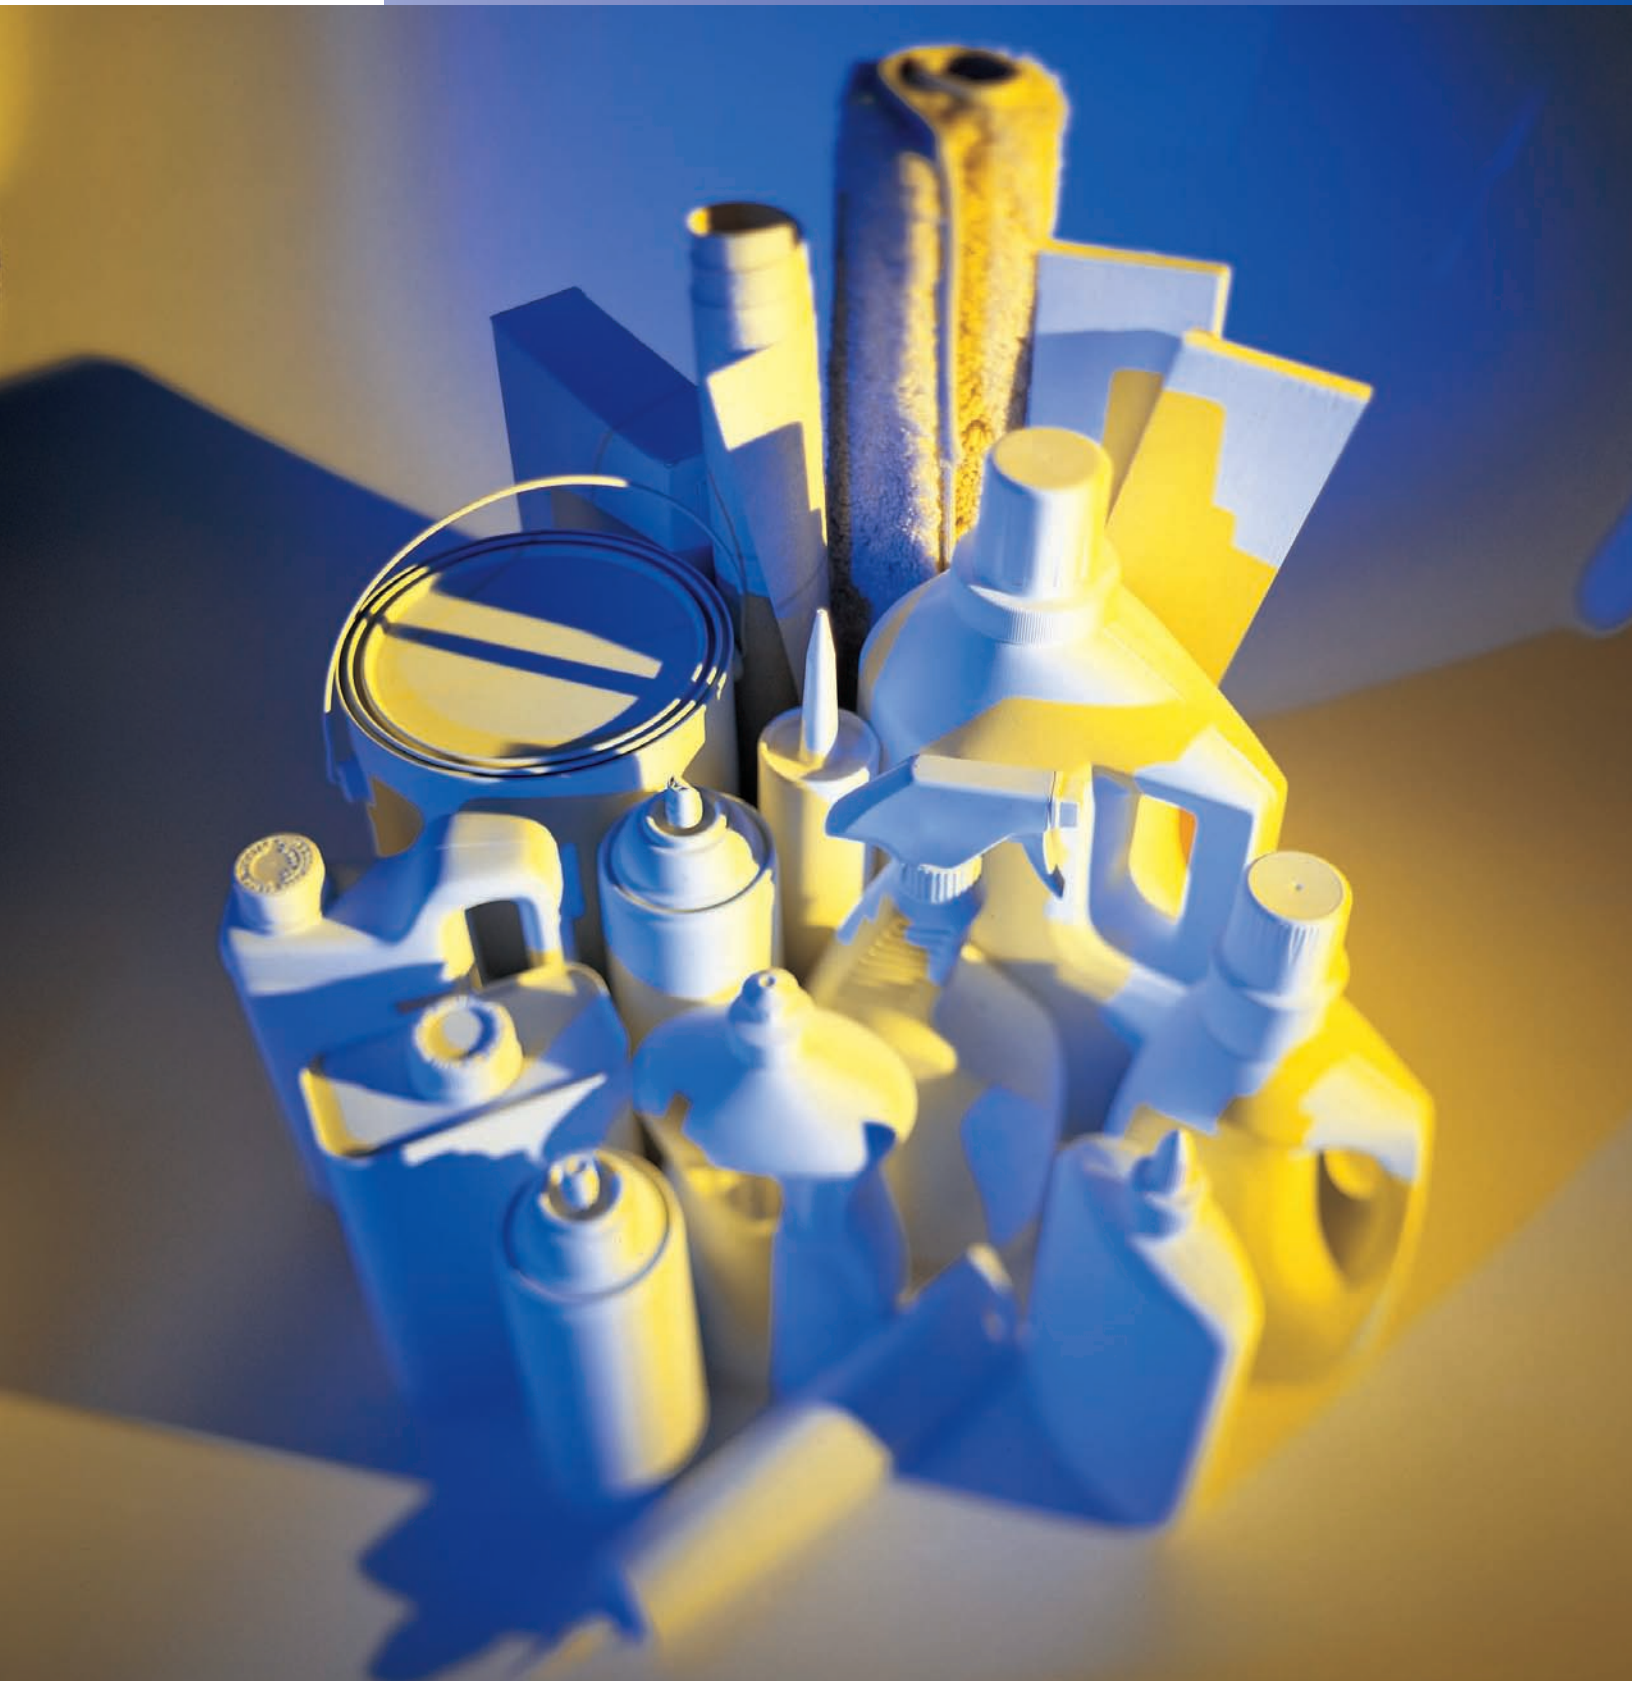
IDENTIFYING COMMON SOURCES

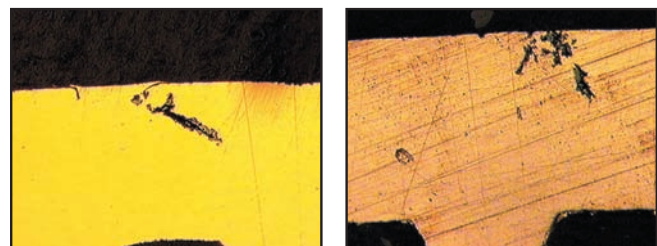
Corrosion Mechanisms

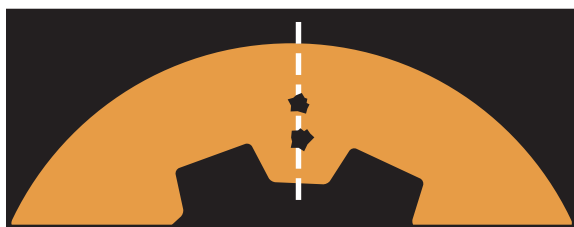
Cross-section showing portion of corrosion (leak)

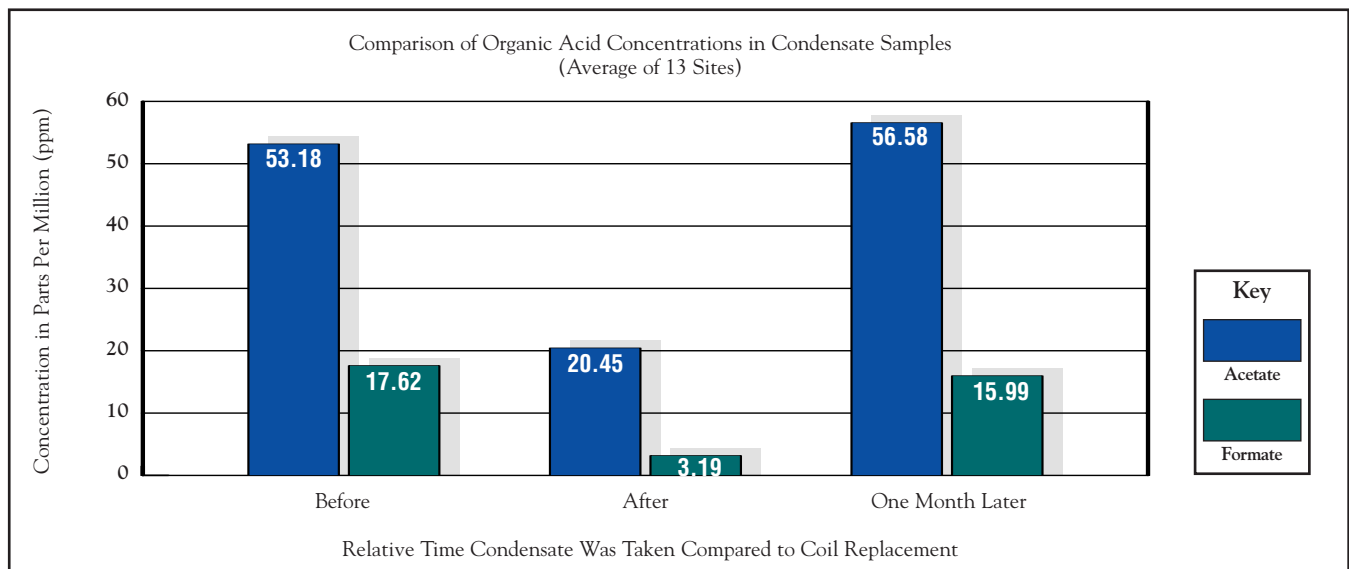
Identifying the sources of agents that cause these failures is certainly a step toward resolving this problem. Carrier is actively working to design a cost-effective yet functional approach to protecting the coil from these corrosive agents. A number of coil coatings are under evaluation for performance, manufacturability and cost. Unfortunately, few materials have performed well in providing protection to the copper tubing. The materials that effectively prevent corrosion have not been easily manufactured or cost-effective.
